CASE STUDY:

Private Office Building; Farmington Hills MI

FACADE REPORT:

Re: WATER INFILTRATION
[Redacted] - Farmington Hills, MI

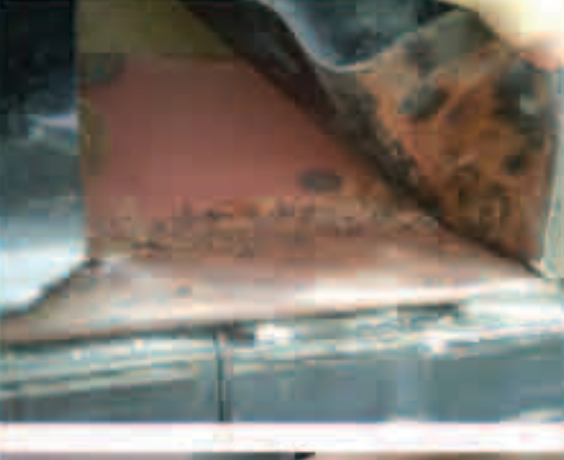
Upon removal of the existing glazed CMU course, it was immediately evident that there is some water infiltration. We took note of tar paper in the wall cavity; this paper is of concern as the characteristics of this material allow it to retain moisture. This is troubling considering its location at the "base" of the wall where water is designed to exit the cavity.

The existing flashing is a semi-rigid polyethylene, not typical in modern construction. Current construction practice utilizes a self-adhering, self-sealing product (similar to Air Shield Thru-Wall Flashing by W.R. Meadows). These flashing products are typically 40 mils thick, with cross-laminated polyethylene film. This film has excellent tensile strength and tear-resistance which is beneficial in this application (around the existing bolted connections).

As suspected, upon removal of the existing semi-rigid flashing, oxidation has accumulated on the existing steel lintel. Oxidation, or the presence of rust, is a clear indicator of the presence of unwanted water in the cavity (and behind the flashing).

The lack of drip flashing at the window head(s) is also contributing to the water migration back into the building. The rounded profile of the existing steel lintel introduces the idea of capillary action, which in essence, brings water back into (and not diverted from) the building envelope. The installation of the drip edge will direct the water away from the building.

We would propose to remove the masonry (approximately 2'4" high) at the existing window head(s), remove the existing flashing system complete and install a new system, similar to the detail(s) provided previously in this report. This would include: (1) self-adhering / self-sealing flashing product; (2) installation of a termination bar with screws & mastic at top of flashing termination (to the back-up sheathing); (3) installation of a tyne-coated drip edge (to match window framing) set in mastic, to allow water to flow over the window away from the building; and the (4) installation of a cell vent / wick weep system to transfer the water from behind the wall cavity through it to the exterior. Cavity/Mesh drainage material would not be required due to the existing masonry in place over head and no mortar "dropping" into the flashing cavity. We would then propose to replace the masonry with new, either glazed CMU to match the existing, or a comparable product. We believe a more cost-effective product would be an integrally colored "red" cast stone product to match the color palette of the existing building. Finally, we would propose a new water application (clear) over the finished work as well as the entire exterior masonry system.

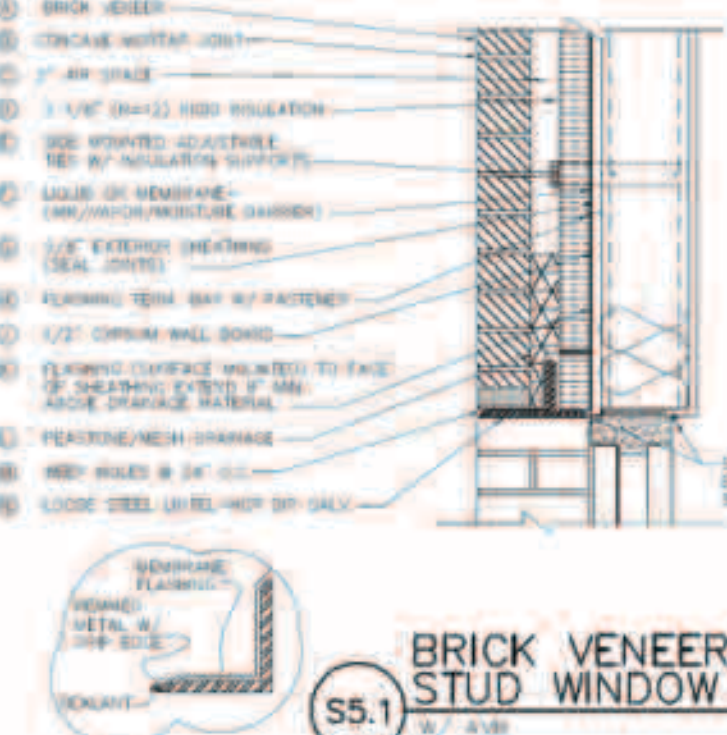
BRICK VENEER/METAL STUD WINDOW HEAD DETAIL
SCALE: N.T.S.

MODERN FLASHING DETAIL
