CASE STUDY:

Private Office Building; Farmington Hills MI

FACADE REPORT:

Re: WATER INFILTRATION
[Redacted] - Farmington Hills, MI

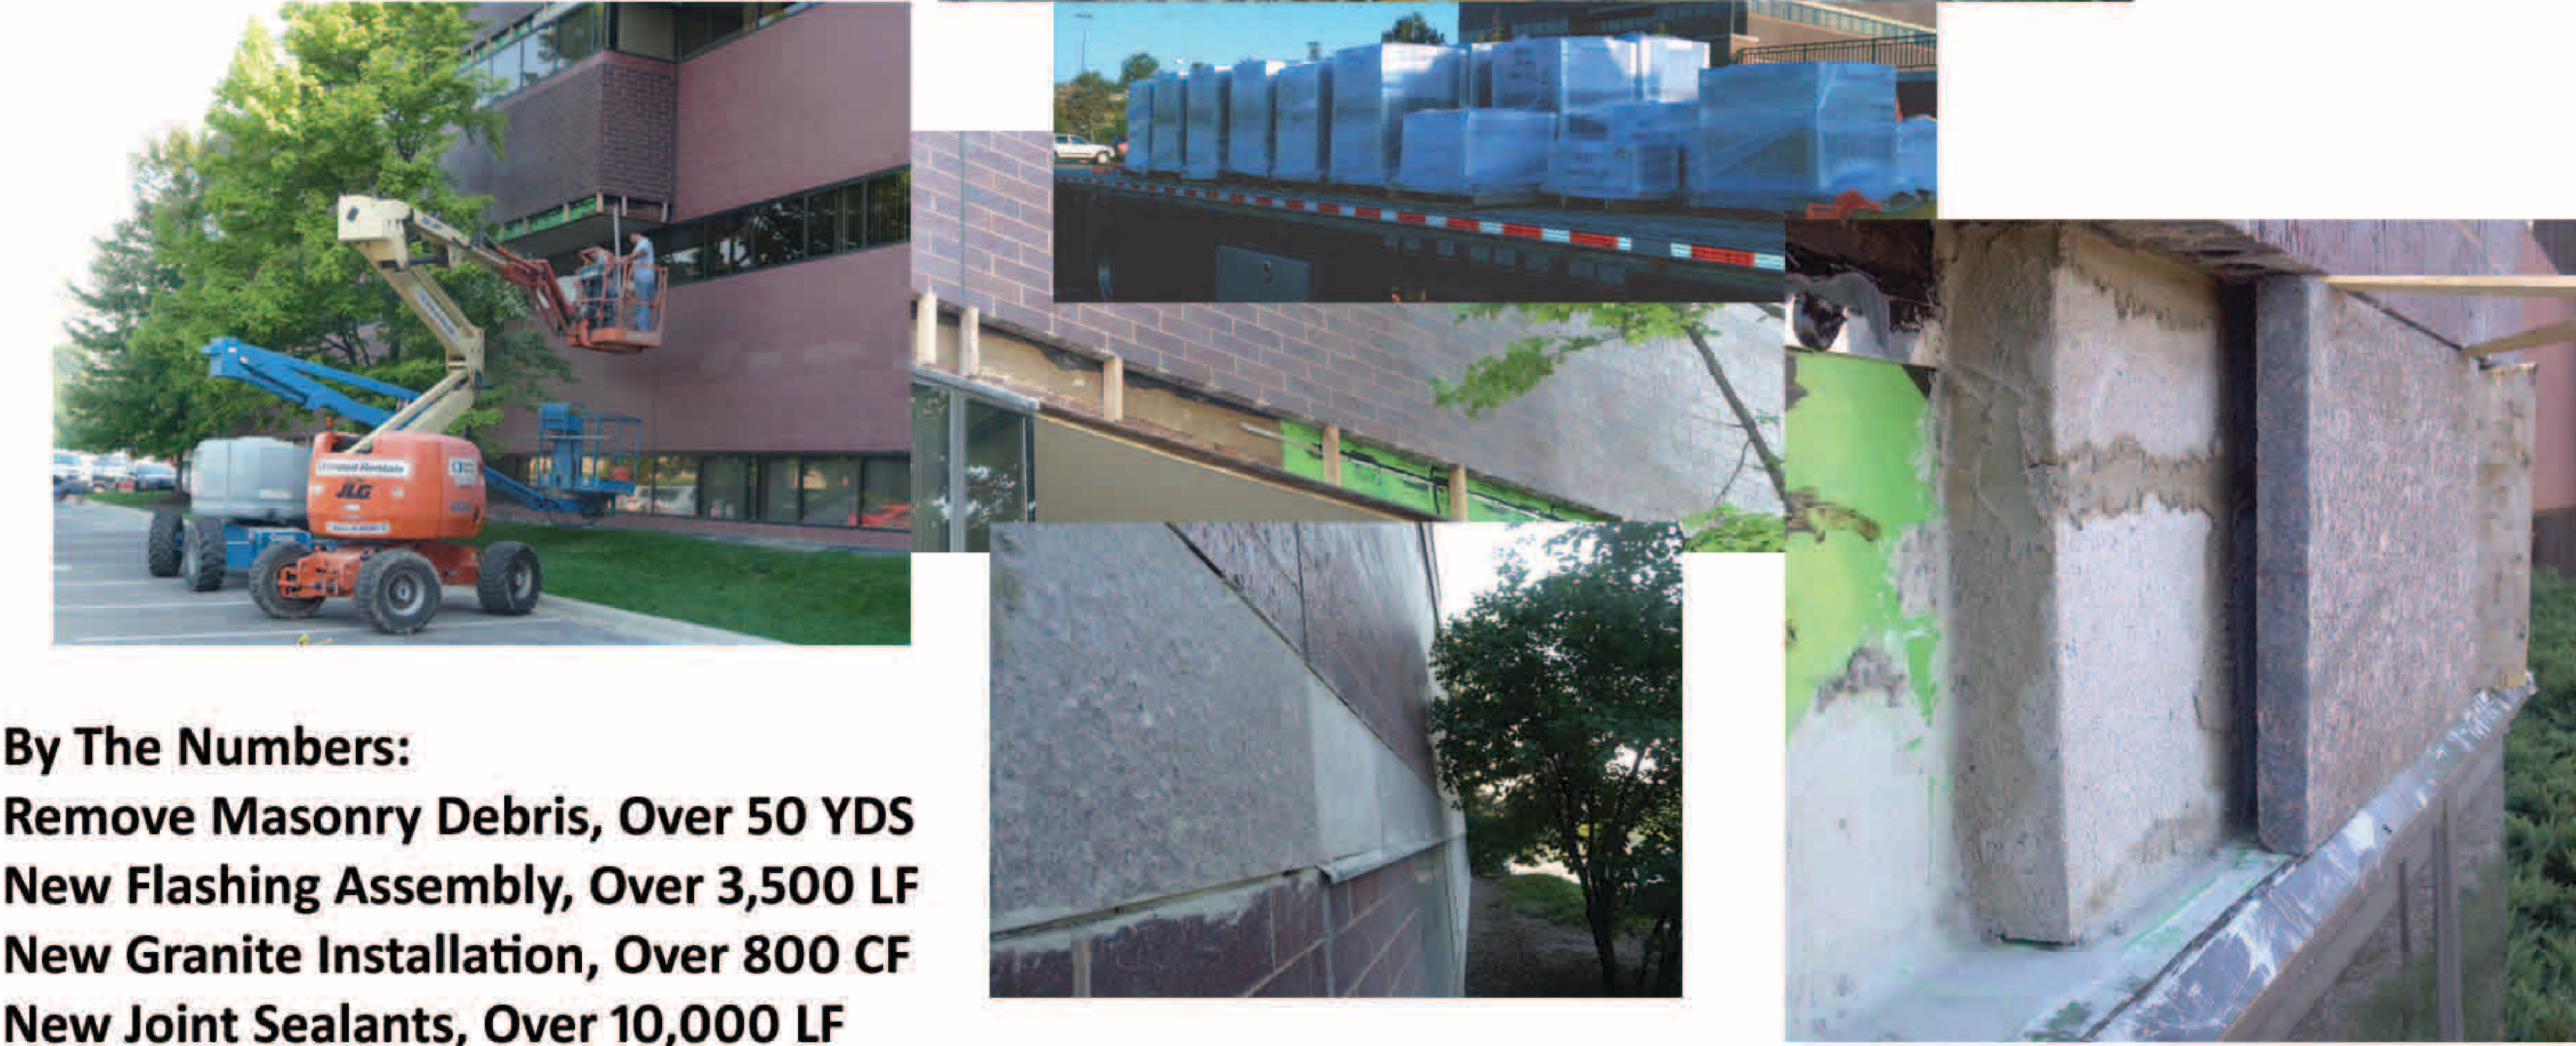
By The Numbers:
Remove Masonry Debris, Over 50 YDS
New Flashing Assembly, Over 3,500 LF
New Granite Installation, Over 800 CF
New Joint Sealants, Over 10,000 LF

Through some exploratory work (see associated report, dated March 15, 2011), we have determined that the existing flashing system is failing, causing water infiltration into the building envelope. We propose to remove the masonry (approximately 2'0" high, or one 8" high course of glazed masonry and one 4" high course of brick) at the existing window head(s), remove the existing flashing system complete and install a new system, to include: (1) self-adhering / self-sealing flashing product (approximately 2'0" up wall), (2) installation of a termination bar (galvanized metal) with screws & mastic at top of flashing termination (to the back-up sheathing); (3) installation of a tyne-coated drip edge (to match window framing) set in mastic, to allow water to flow over the window away from the building; and the (4) installation of a cell vent / wick weep system (at 2'0" on center) to transfer the water from behind the wall cavity through it to the exterior. We will also install a substrate of 2" solid masonry for the granite back-up. Once the new flashing system is properly installed, we will replace the removed masonry with a 1'0" high by 2'0" long (8m thick) granite product to be provided by [Redacted]. The top joint of the granite (between the granite and brick) will be raked and filled with DOW Silicone sealant, as well as all of the head joints between the granite panels (1/4" thickness).
